DATA RECOVERY / HARD DISK TECHNICAL NOTES

Title: Electronics Failure on Maxtor Diamond Max Plus 9

Drive: Maxtor Diamond Max Plus 9 (6Y080L0 series)

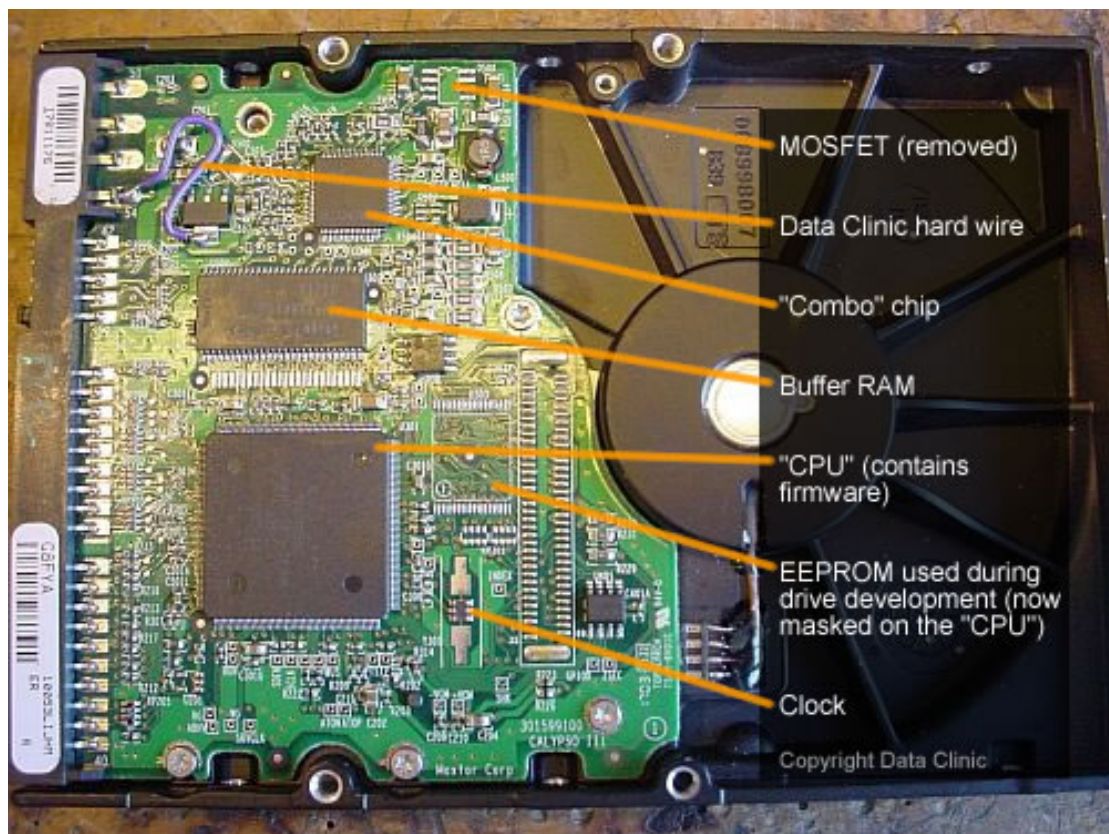
Symptoms of Failure: Drive Dead

Notes: The Maxtor Diamond Max Plus 9 is a very popular drive that is subject to all the usual types of hard disk failure. In this example the primary cause of the failure was electronic.

The power to this drive is 3 phase & oxidation is a common cause of losing a phase. Loss of one or more phases will (in most conditions) cause the MOSFET to fail. This in turn will cause the "combo" chip to fail and secondary damage will also be sustained to (a) the board (b) further electronic components surrounding the MOSFET and "combo" chip (c) the read / write head chip. Electrical damage is not limited to the controller board as the read / write chip is located on the head assembly and to reach it requires the drive to be stripped down in a clean room.
