DATA RECOVERY / HARD DISK TECHNICAL NOTES

Title: IBM Travelstar – Motor disassembly

Drive: IC25N020ATCS04-0

Notes: Sample pictures from the disassembly of the spindle motor and fluid bearing from an IBM Travelstar IC25N020ATCS04-0 hard disk.

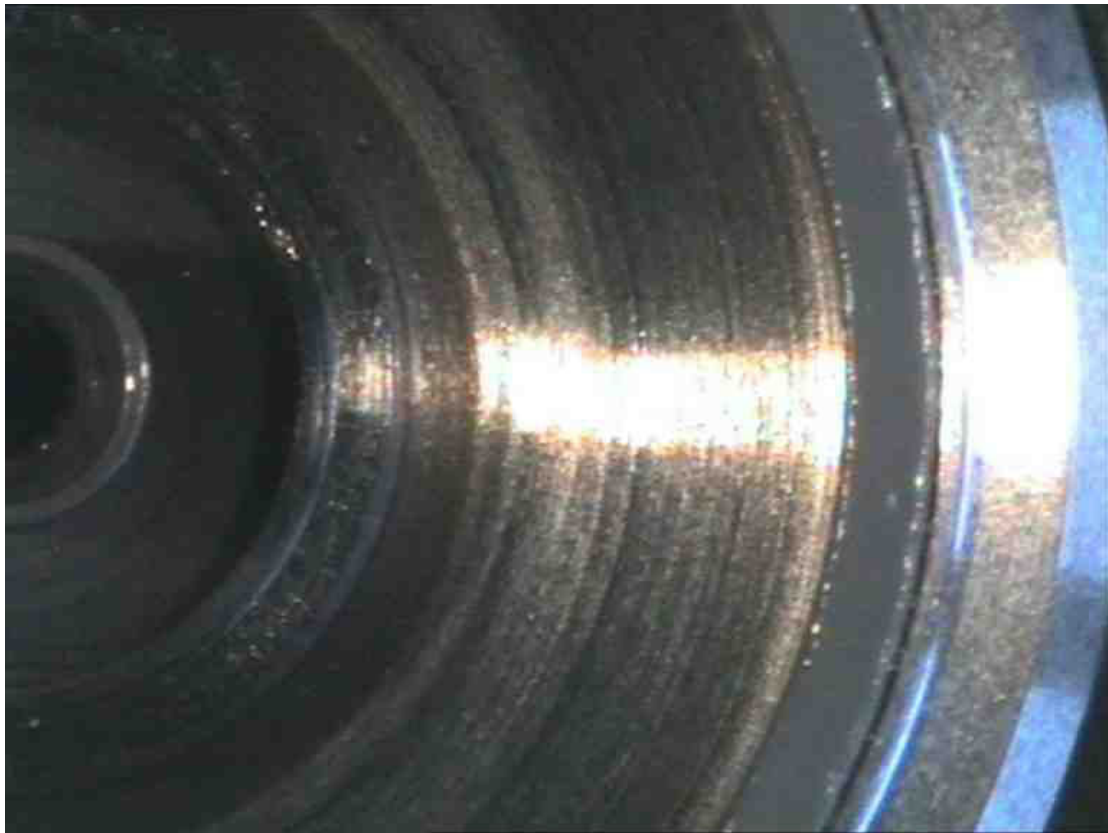
Above: Bottom view of the spindle rotor on an IC25M020ATCS04-0. On the opposite side is the screw that locks the platter

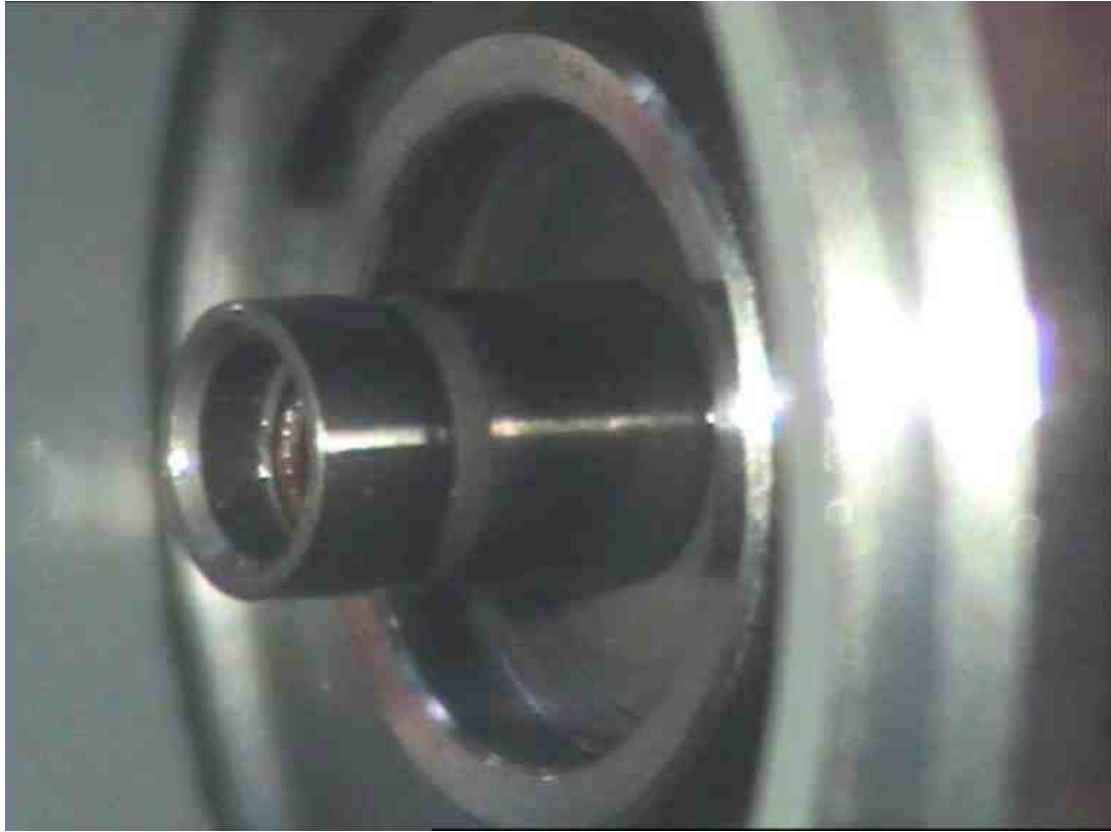
Above: Side view of the rotor, showing the (fluid) bearing surface.

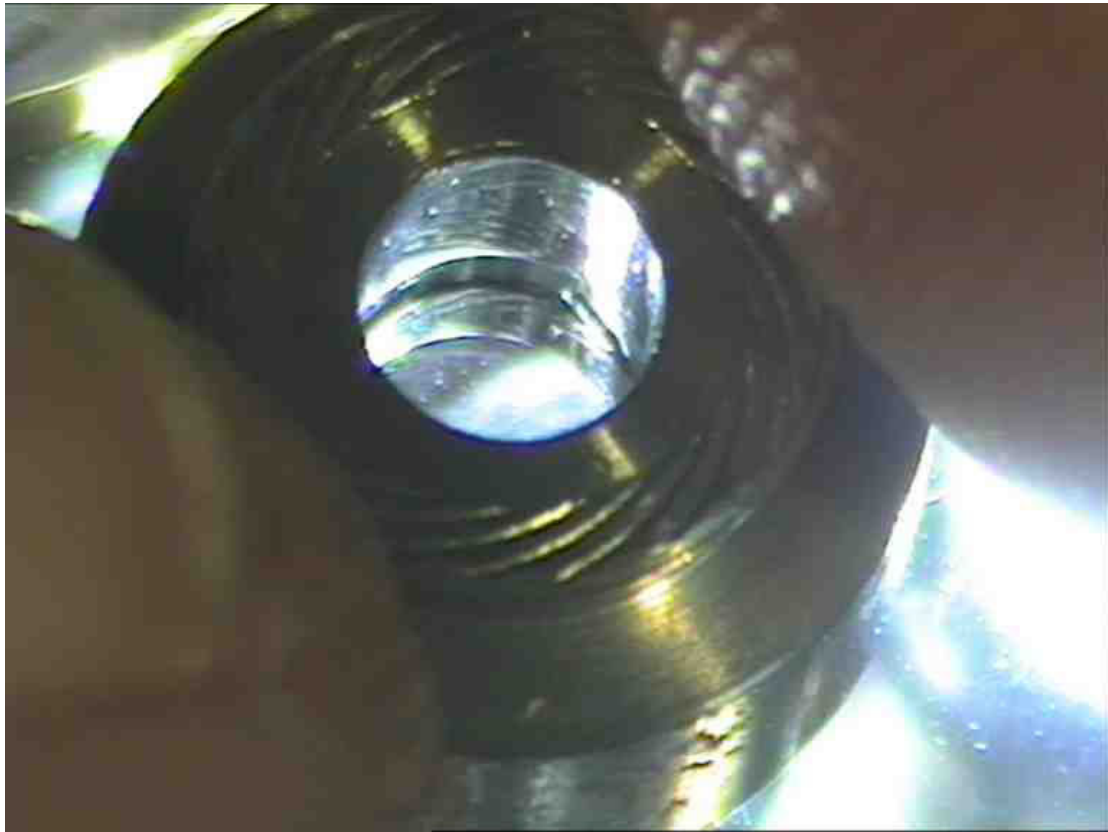
Above: The starter bearing, the lightened central surface mating with the dark cylinder of the above. The engraved slot in the middle contains the fluid, top ring with arcs dynamically prevent fluid escape. This small cylinder is fixed into the disk chassis.
